CASE STUDY

Alice Billings House, London

Full Interior Fitout & Refurbishment

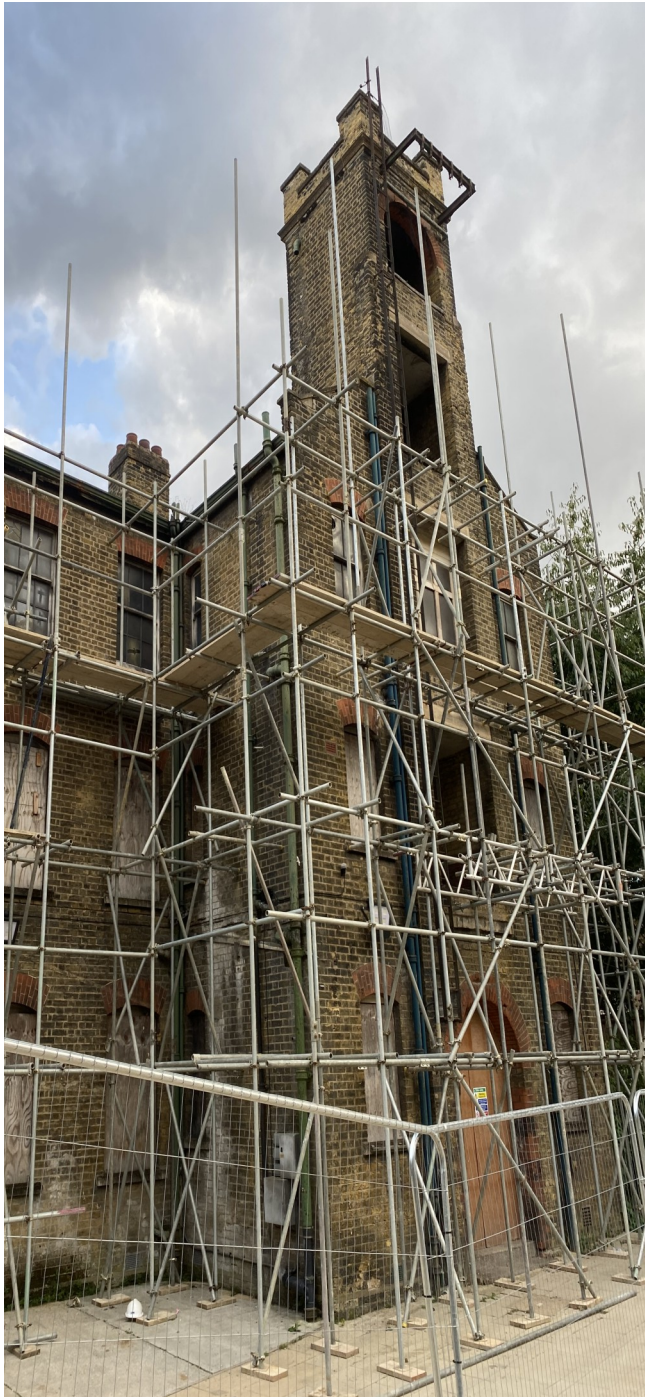
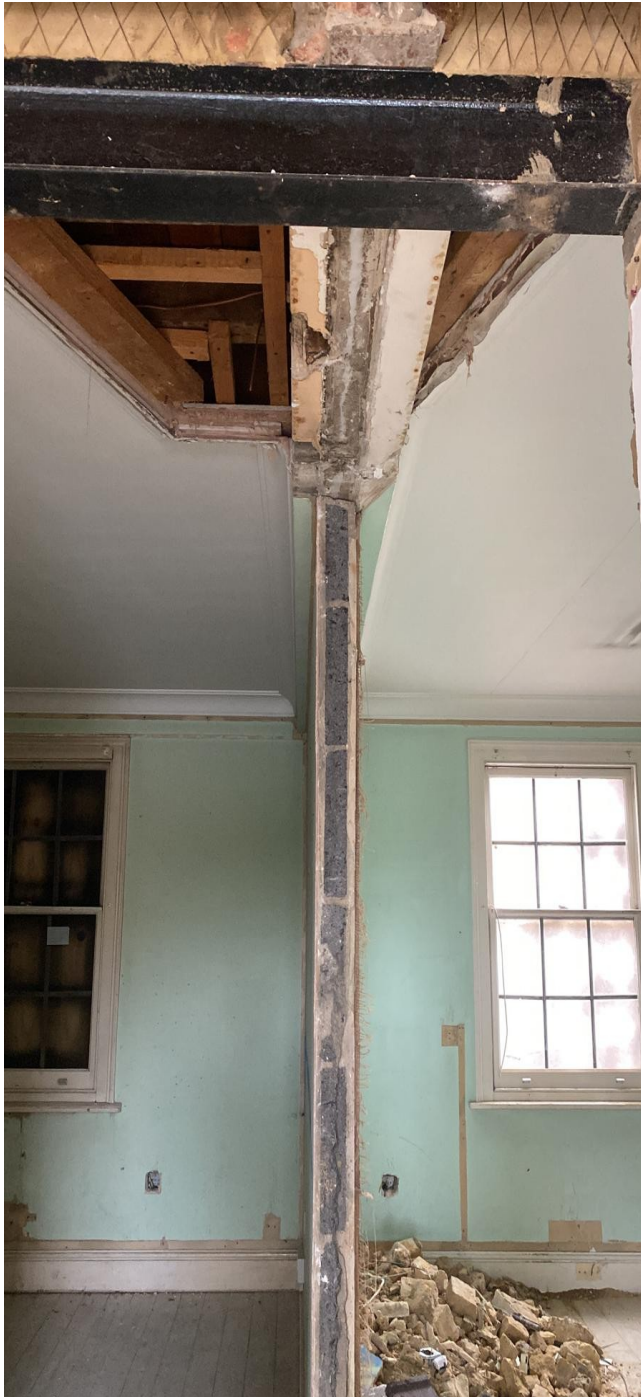
Works included a full removal of the roof coverings to the North Block, extensive strengthening works to the trusses, provide insulation between the joists and recover the roof utilising existing slates where possible, not only to make the premises watertight but also to bring to current regulations.

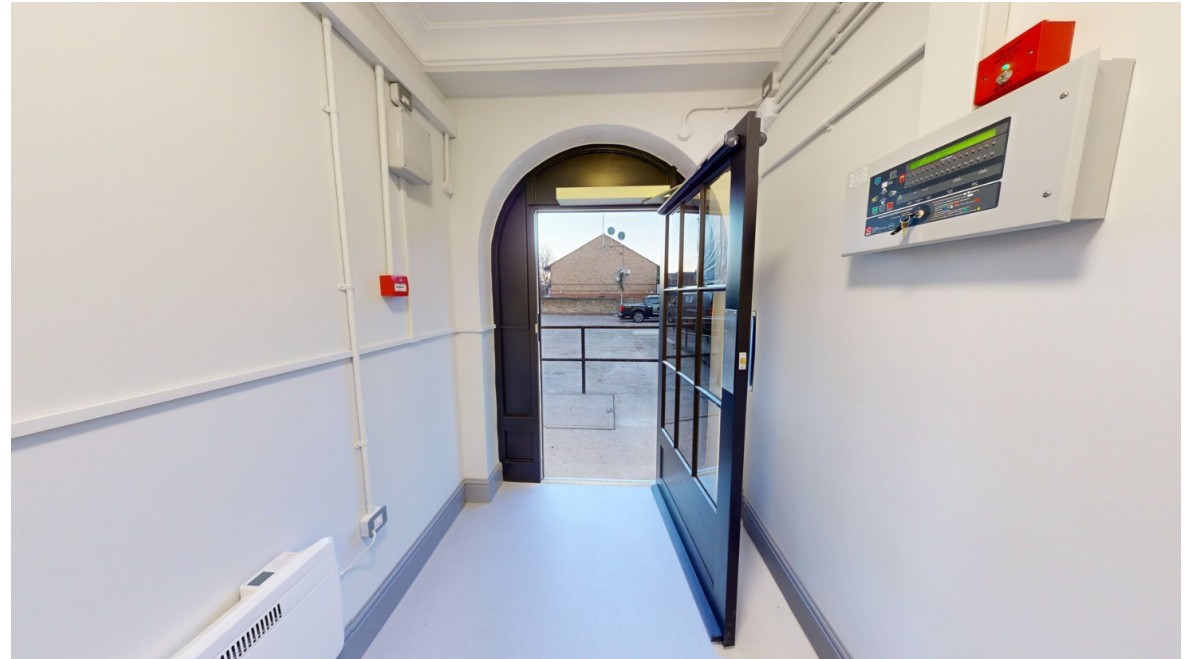
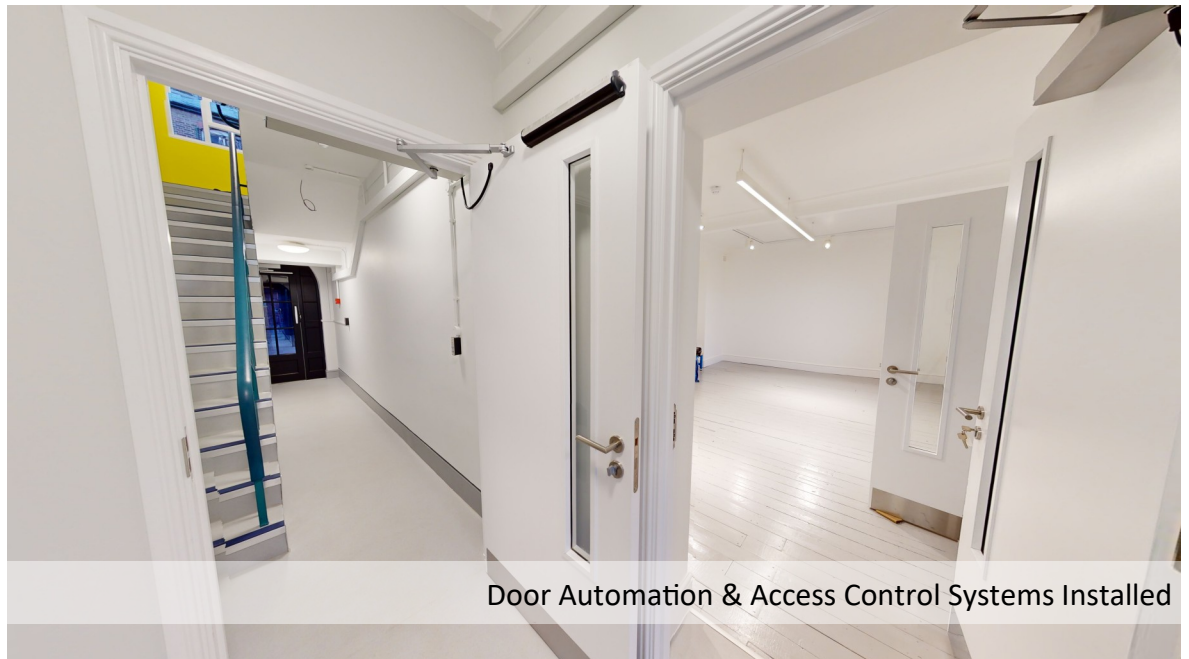
The first phase of works also included whole sale strip-out of all Mechanical, Electrical & Plumbing services to the South Block, the design and installation of new electrical services, plumbing and below ground drainage. A variety of structural adaptations were also made to open the building up into a creative workspace for local artists.

A new watermain was installed to replace the existing lead watermain and a number of repairs were undertaken to the below ground drainage leading away from the property.

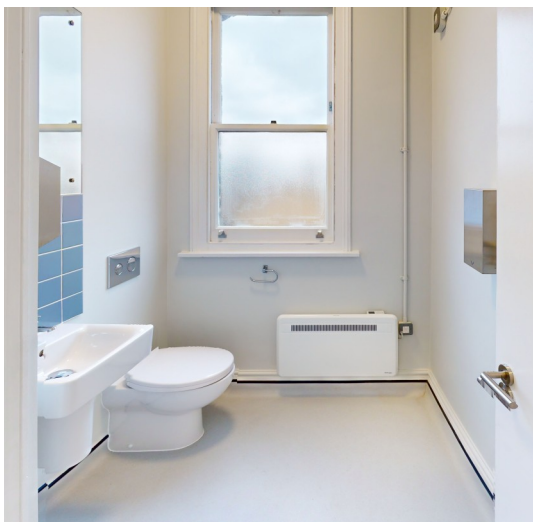
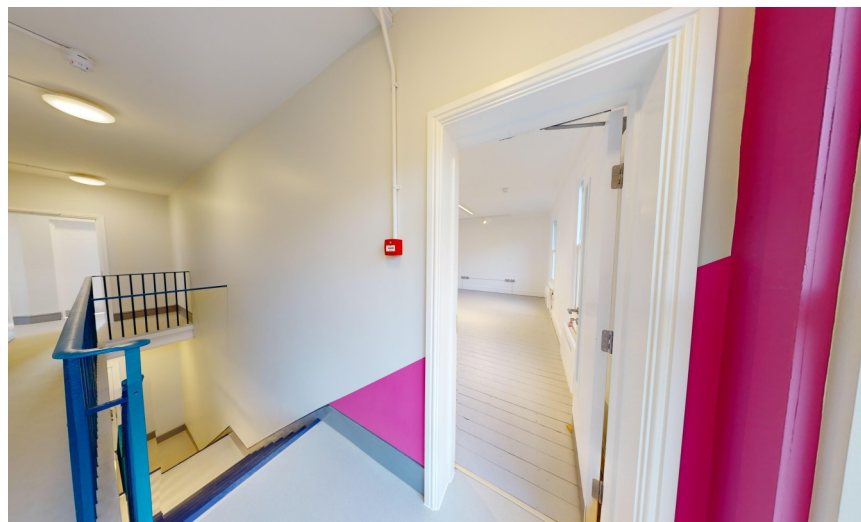
All walls were finished in white, and floors painted grey to allow the incoming tenant their to apply their own touches when they came to occupy the space. A colour feature wall to each level of the communal staircase was requested by the architect to help encourage creativity.

The Diamond team addressed the badly degraded timber sash windows with comprehensive restoration methods. New tea points, WCs and shower rooms were installed across all 3 floors, including DDA accessible areas.
